**Flood Control Project Maintenance  
Levee Inspections**

**Fall 2010 Levee Maintenance Deficiency Summary Report**

**Flood Control Project Maintenance  
Levee Inspections  
Unit Cover Sheet  
Fall 2010 Levee Inspection Results  
City of Sacramento**

**Levee Inspection Report By Mile - Fall 2010**

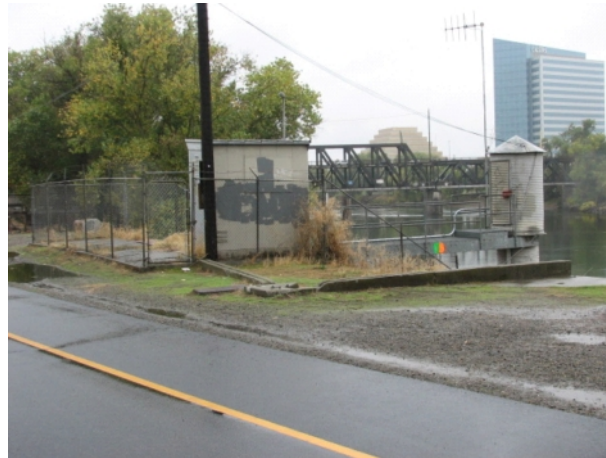
Levee Mile Report Line	1
Start Levee Mile	0.14
End Levee Mile	0.14
Location	Water Side
Category	Earthen Levee
Item	Encroachments

I Street recorder can

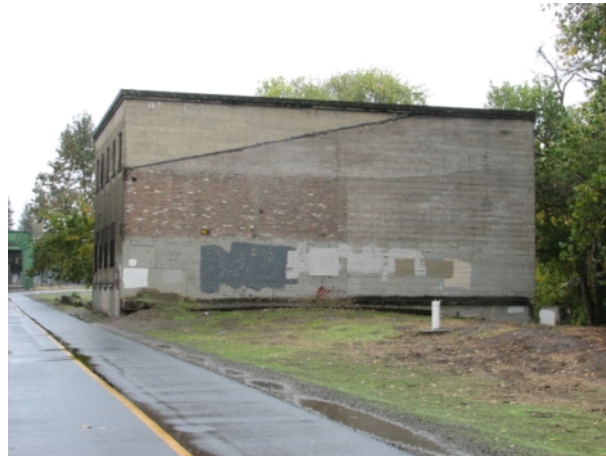
Levee Mile Report Line	2
Start Levee Mile	0.16
End Levee Mile	0.16
Location	Water Side
Category	Earthen Levee
Item	Encroachments

Historical Building with foundations and Ramps on upstream and downstream sides

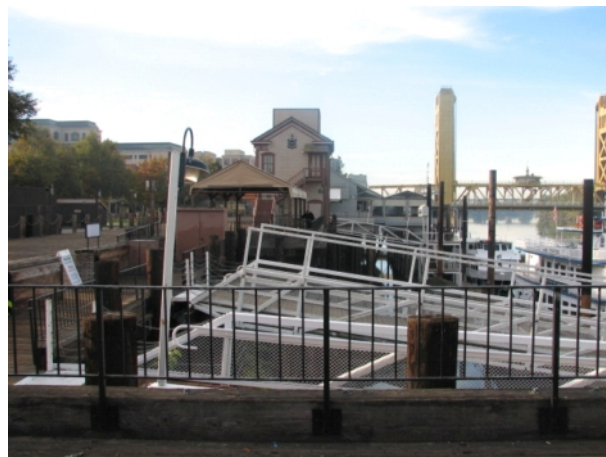
Levee Mile Report Line	3
Start Levee Mile	0.37
End Levee Mile	0.73
Location	Crown
Category	Earthen Levee
Item	Encroachments

Photo looking downstream from the Delta King of Old Sacramento.

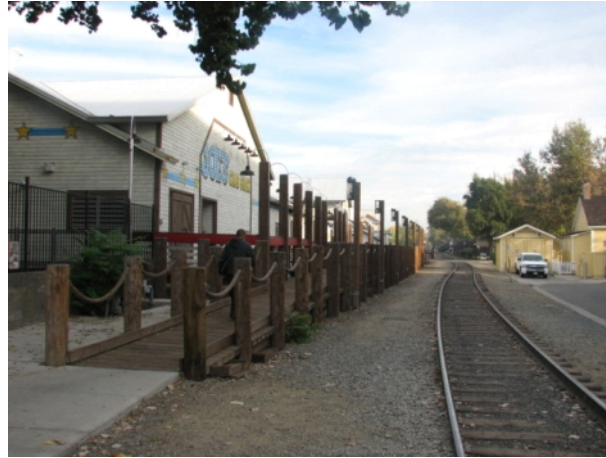
Levee Mile Report Line	3
Start Levee Mile	0.37
End Levee Mile	0.73
Location	Crown
Category	Earthen Levee
Item	Encroachments

A look at Joe's Crab Shack on the levee in Old Sacramento.

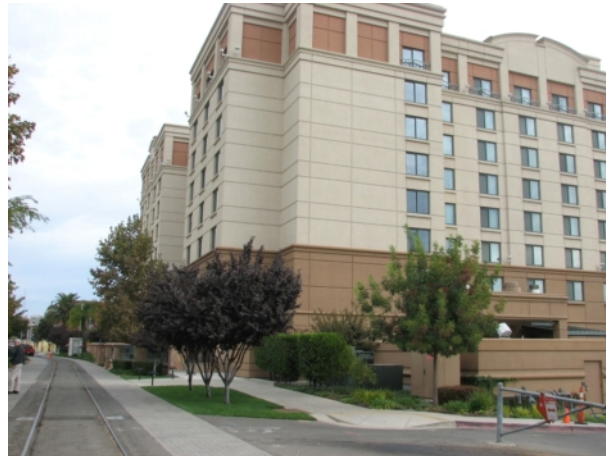
Levee Mile Report Line	4
Start Levee Mile	0.78
End Levee Mile	0.78
Location	Crown
Category	Earthen Levee
Item	Encroachments

Embassy Suites

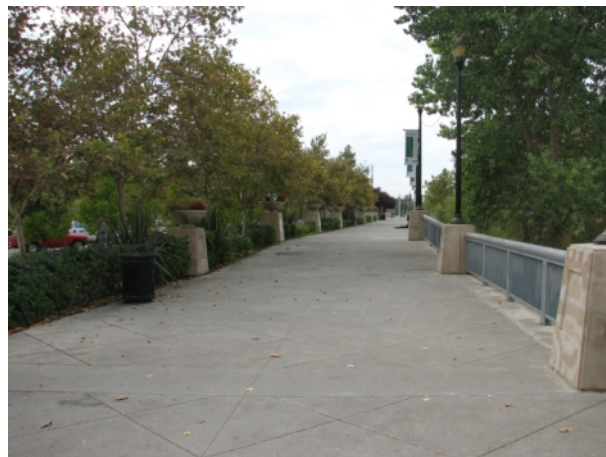
Levee Mile Report Line	5
Start Levee Mile	0.78
End Levee Mile	1.17
Location	Crown
Category	Earthen Levee
Item	Encroachments

5	0.78	1.17	Earthen Levee	Encroachments	CR	PO	Landscaping Inspector Comments: River walk along the water front	38.579705 ° -121.507360 °	38.574710 ° -121.510208 °	5 Y	
6	1.33	1.40	Supplemental	USACE Erosion Survey	WS	M	Inspector Comments: 2009: no berm, 2:1 slope, holes, sands and silts, 4.81 ft/s [2009 SiteID:SAC_58-4_L]	38.573133 ° -121.512278 °	38.572342 ° -121.513175 °	15 Y	
7	1.38	1.38	Earthen Levee	Encroachments	CR	M	Equipment Inspector Comments: the two box cars replace the sheds.	38.572320 ° -121.512668 °	38.572320 ° -121.512668 °	3 Y	
8	1.46	1.46	Earthen Levee	Encroachments	CR	M	Equipment Inspector Comments: The trains have been move upstream to this new location.	38.571477 ° -121.513744 °	38.571477 ° -121.513744 °	9 Y	
9	1.52	1.52	Earthen Levee	Encroachments	CR	PO	Buildings Inspector Comments: Storage sheds have been removed and two box cars have replaced them.	38.572267 ° -121.512312 °	38.572267 ° -121.512312 °	11 Y

River walk crown with landscaping

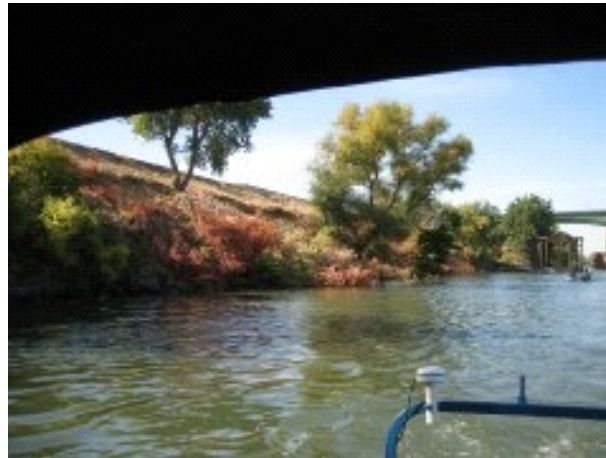
Levee Mile Report Line	6
Start Levee Mile	1.33
End Levee Mile	1.40
Location	Water Side
Category	Supplemental
Item	USACE Erosion Survey
2009: no berm, 2:1 slope, holes, sands and silts, 4.81 ft/s [2009 SiteID:SAC_58-4_L]	
johngw_f_20101012_057.JPG

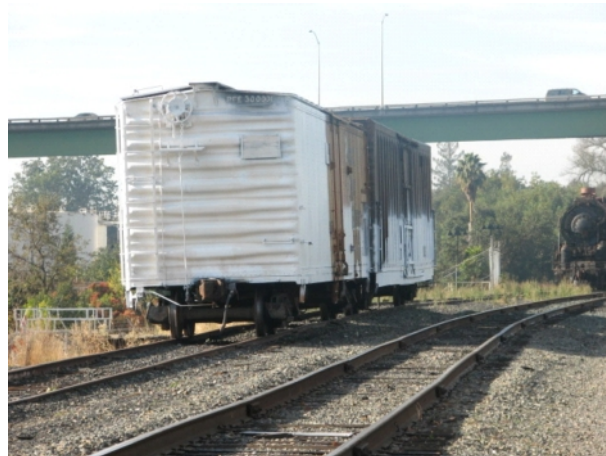
Levee Mile Report Line	8
Start Levee Mile	1.46
End Levee Mile	1.46
Location	Crown
Category	Earthen Levee
Item	Encroachments
The equipment sheds have been removed and two box cars have been put in their place.	
johngw_f_20101108_310.jpg

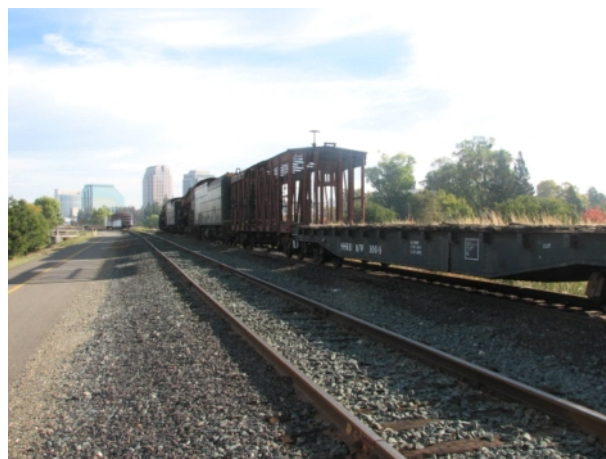
Levee Mile Report Line	8
Start Levee Mile	1.46
End Levee Mile	1.46
Location	Crown
Category	Earthen Levee
Item	Encroachments
The trains that were at 1.54 have been pulled upstream to this location. The CVFPB has asked that they be removed from the levee.	
johngw_f_20101108_311.jpg

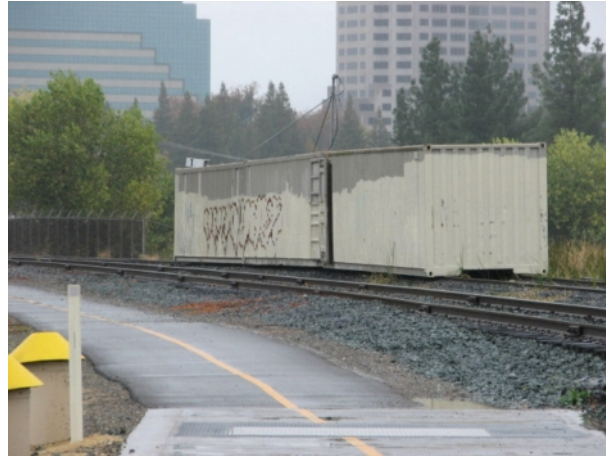
Levee Mile Report Line	9
Start Levee Mile	1.52
End Levee Mile	1.52
Location	Crown
Category	Earthen Levee
Item	Encroachments
Storage bins on tracks placed by Railroad Museum	
johngw_f_20101012_055.jpg

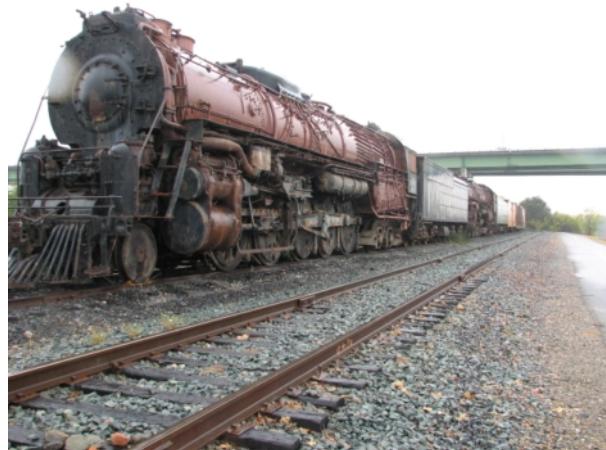
10	1.54	1.54	Earthen Levee	Encroachments	CR	W	Equipment Inspector Comments: This area is a concern due to work the COE did at Pioneer Reservoir with a stability berm and monitoring wells on the land side. This is due to the levee seepage. The concern is that the weight of the train cars may cause problems. Total eight cars.	38.571495 ° -121.513615 °	38.571495 ° -121.513615 °	12 Y	
11	1.73	1.96	Earthen Levee	Encroachments	CR	W	Equipment Inspector Comments: Levee is oversize with railroad tracks and paved parking this area is Miller Park	38.568172 ° -121.516042 °	38.564882 ° -121.516265 °	6 Y	
12	1.96	2.34	Earthen Levee	Encroachments	CR	W	Equipment Inspector Comments: Railroad tracks run on crown of levee, paved roadway runs along toe on waterside this is Miller Park Marina area.	38.564900 ° -121.516253 °	38.559460 ° -121.515085 °	7 Y	
13	2.45	2.45	Earthen Levee	Vegetation	LS	W	Elderberries are blocking visibility and flood fight capability.	38.557937 ° -121.514237 °	38.557937 ° -121.514237 °	8 Y

Levee Mile Report Line	10
Start Levee Mile	1.54
End Levee Mile	1.54
Location	Crown
Category	Earthen Levee
Item	Encroachments
Picture of most of the train cars City of Sacramento is concerned about the weight of the cars on the levee This area has a seepage problem	
johngw_f_20101012_056.jpg

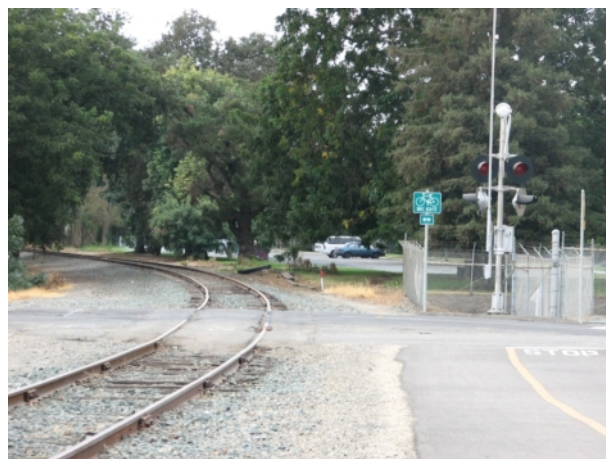
Levee Mile Report Line	11
Start Levee Mile	1.73
End Levee Mile	1.96
Location	Crown
Category	Earthen Levee
Item	Encroachments
Miller Park at Broadway railroad track and parking area on levee	
johngw_f_20101012_052.jpg

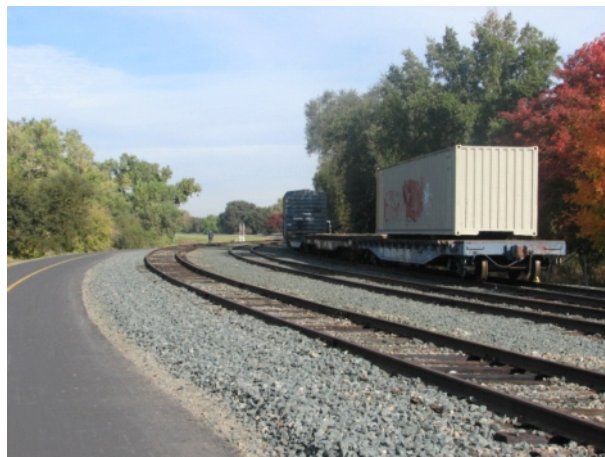
Levee Mile Report Line	15
Start Levee Mile	3.29
End Levee Mile	3.29
Location	Crown
Category	Earthen Levee
Item	Encroachments

LMR No.	Levee Mile		Category	Item	* Location	** Rating	Action/Comment	GPS Latitude/Longitude		Issue No.
	Start	End						Start	End	Photo
15	3.29	3.29	Earthen Levee	Encroachments	CR	W	Equipment Inspector Comments: Flat cars and railroad tracks on crown.	38.546165 ° -121.510165 °	38.546165 ° -121.510165 °	16 Y

Flat cars have been left on a third track at the  
switching area before I-5 crossing.
